## **Sequential Disaster Forensics: An Application to Floods in the City of Grimma**

*Marina Mendoza, Reimund Schwarze*

November 2018

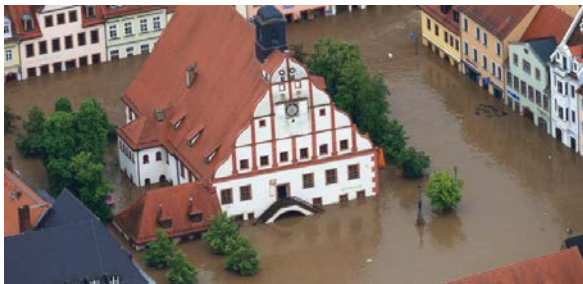
*Figure 4 Grimma city hall during the flood in 2002* *Figure 5 Grimma city hall during flood in 2013 (UFZ)*  
*(Welt.de, dpa / Jens Wolf)*

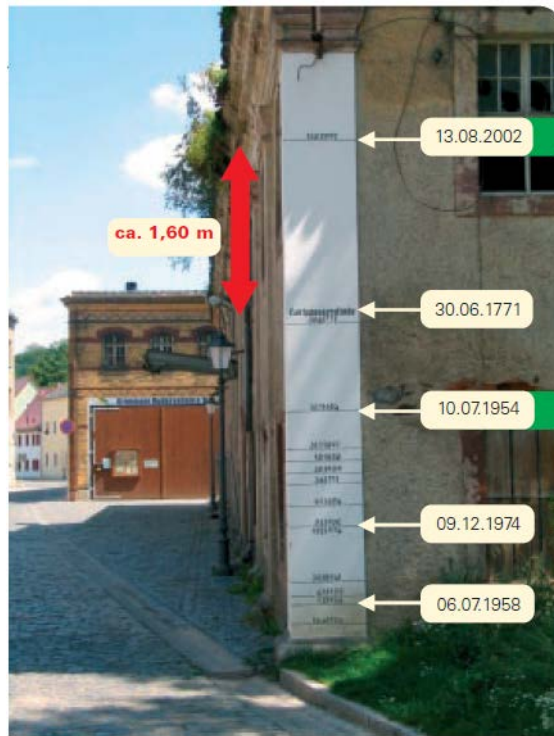
Figure 14 Water level of historic floods, on the Großmühle building in Grimma centre (Landestalsperrenverwaltung des Freistaates Sachsen, 2006).

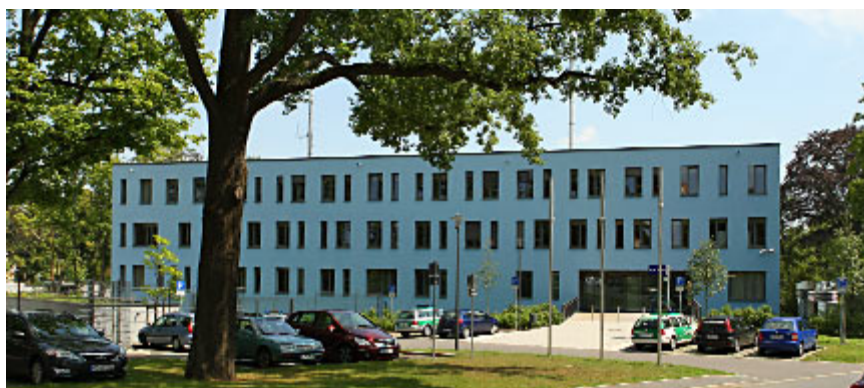
*Figure 19* One of the buildings of the new police station in Grimma (<https://www.polizei.sachsen.de/de/14607.htm>)

This is also true for the years between floods and corroborated by the satellite images reported below. There are minor changes that regard two parking lots, where in one case some trees were taken down and more park space was added for a supermarket in between the years 2000 and 2009. An important exception regards the police headquarters that were established around the year 2005 with federal funds. The police station serves the entire Grimma municipality, not just the historic centre, and consists of four buildings, located next to the Mulde River, south of the town centre (Figures 18, 19). One of these buildings was built at the beginning of the 20<sup>th</sup> century and was renovated to be part of the police station. After the refurbishments, it was flood proofed as part of one of the “flood wall” projects.

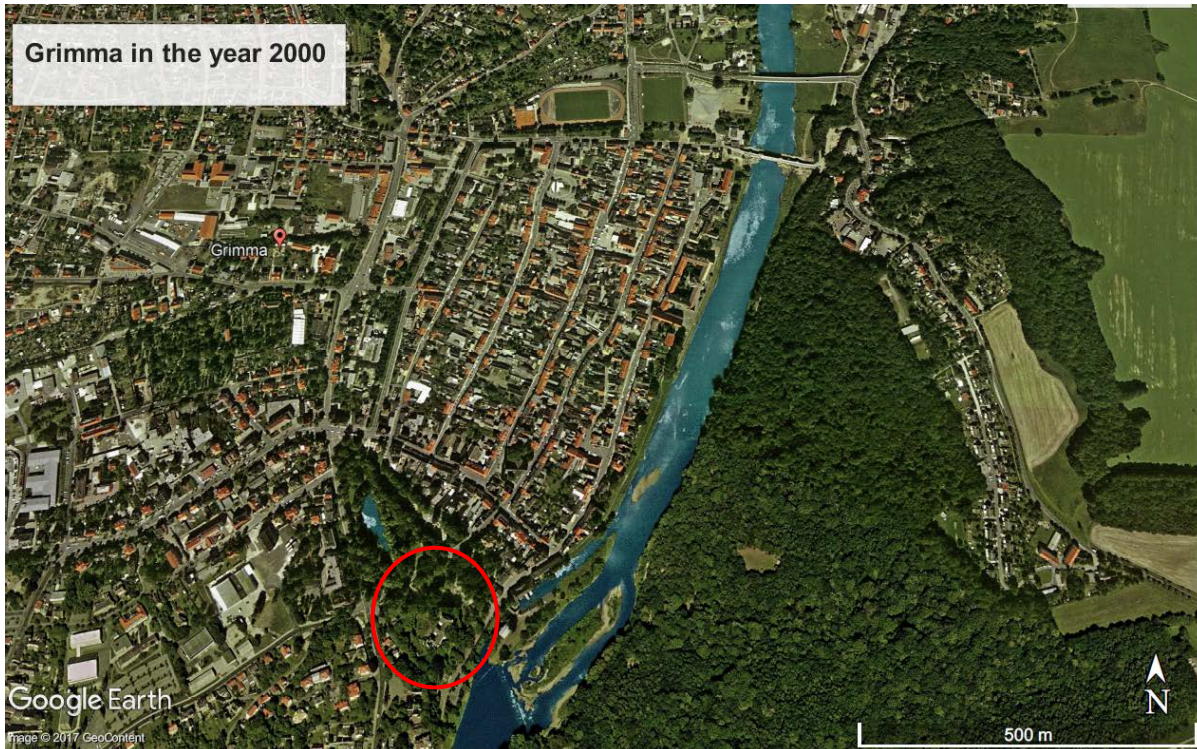
*Figure 20* Satellite image of Grimma in 31-10-2000 (Google Earth2017)

Even if the built-environment in its physical aspect mostly did not change from one flood event to the other, as shown by the satellite images (Figure 20, Figure 21, Figure 22), the buildings' function could have changed, and thus affecting their vulnerability. This is true regarding their physical vulnerability when considering a possible refurbishment in the interiors and contents, but mainly regarding their functional vulnerability. The 2002 flood put the town of Grimma under the media's spotlight, both local and international, as shown by articles in newspapers at that time. An example is an article on CNN of August 20, 2002, where different damages in Grimma are reported. Furthermore, even the mayor at that time recognised the focus that the media had on Grimma. This fact, plus the quick reconstruction and refurbishment of the buildings to an even better state than before the flood, made the city more attractive to tourism. All the buildings were renovated, even the ones that had never been refurbished before (Mrs. Guhlemann in the interview 2005).

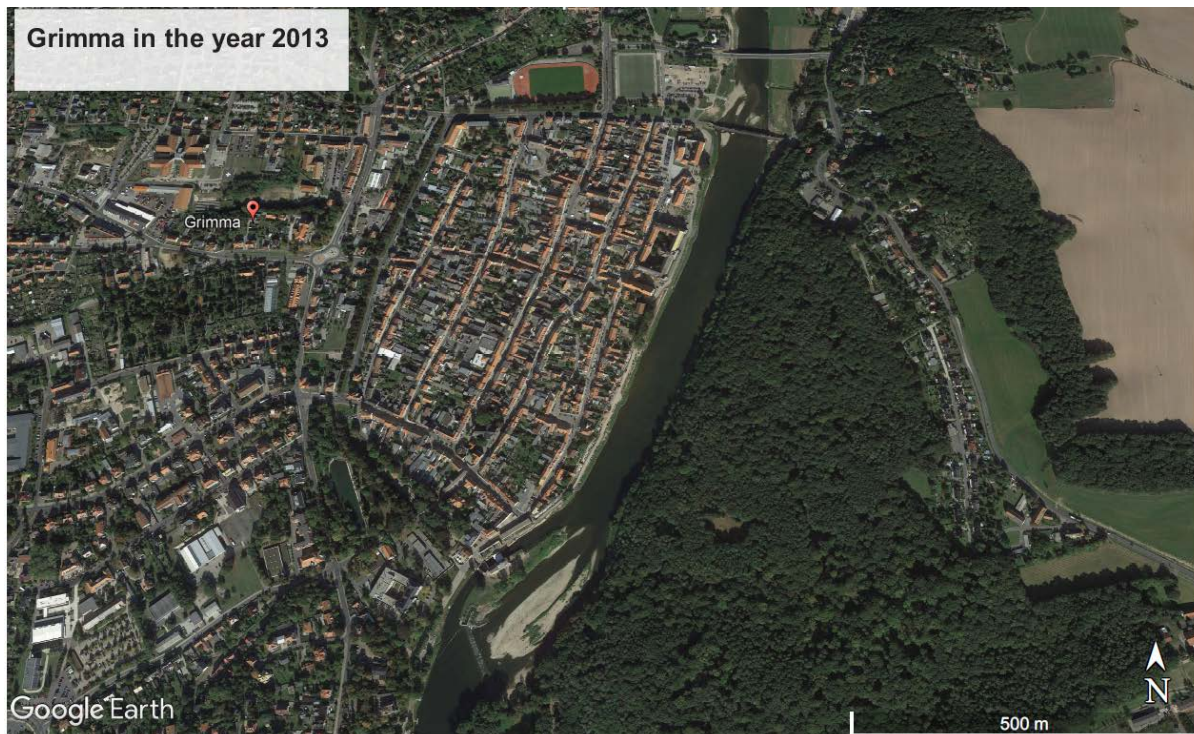
**Figure 22** Satellite image of Grimma in 30-09-2013 (Google Earth2017)

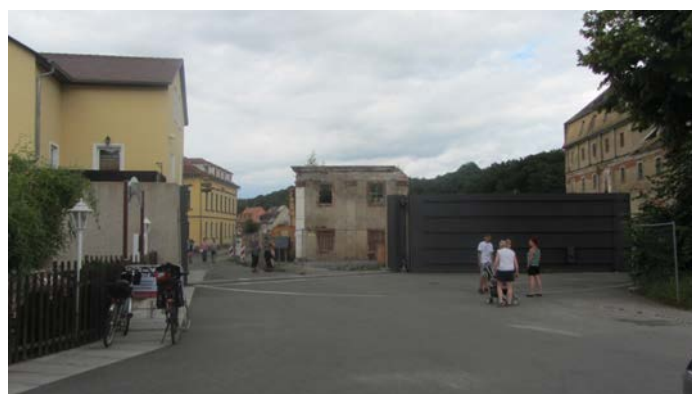
*Figure 27 Floodgate, part of the floodwall Project 1*

Project 1 (Figure 26) includes the area from the street "Kellerhäuser" to the north end of the boathouse. The police station buildings, the new garages, a restaurant, the old rye mill and the boathouse will be surrounded by the walls. The short sections between the buildings are protected by free-standing walls. The height of the wall varies between 1.5 m (new police building) and about 4 m (rye mill/boathouse) (hochwasserschutz-grimma.de, 2017). The historic building that is part of the police new Headquarters, built around 1900, will be integrated into the flood protection scheme and, thus, floodproofed. Another important element of Project 1 is the floodgate, next to the old rye mill (Figure 27).

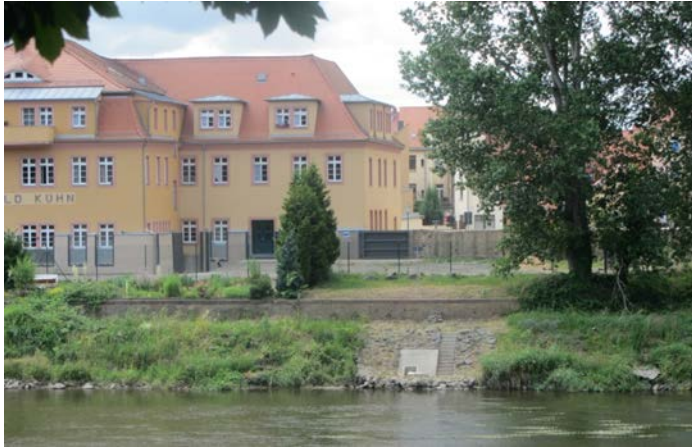
**Figure 3** *New floodwall, part of Project 2, with passageways for accessing the river and allowing a view (2017, authors)*  
short notice in case of imminent floods (hochwasserschutz-grimma.de, 2017).

In Project 2, the old city wall from the boathouse to the monastery church, the new wall was erected directly in front of the existing city wall. The height of the floodwall varies between 3.5 m and 4.5 m. Three passageways were left on the wall to guarantee access to the river (Figure 40). All three passages are equipped with a high-water protection gate on the waterside so that the waterways can be closed at

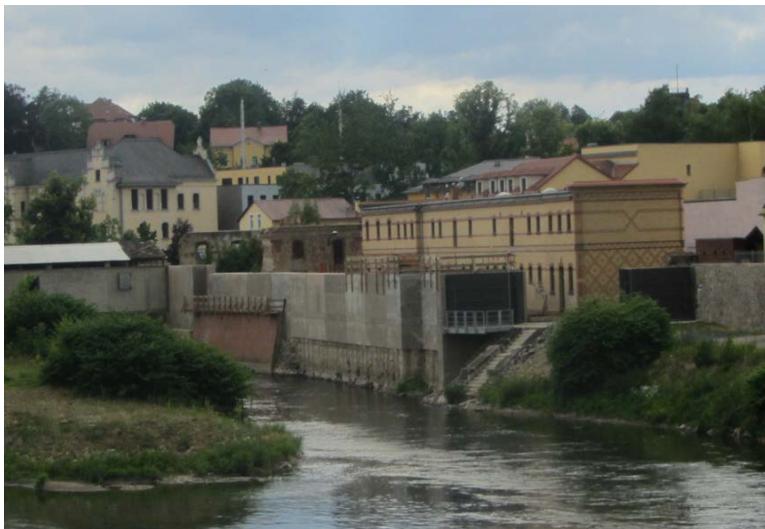
**Figure 4** *Floodwall, Project 2, under construction (June 2017, authors).*

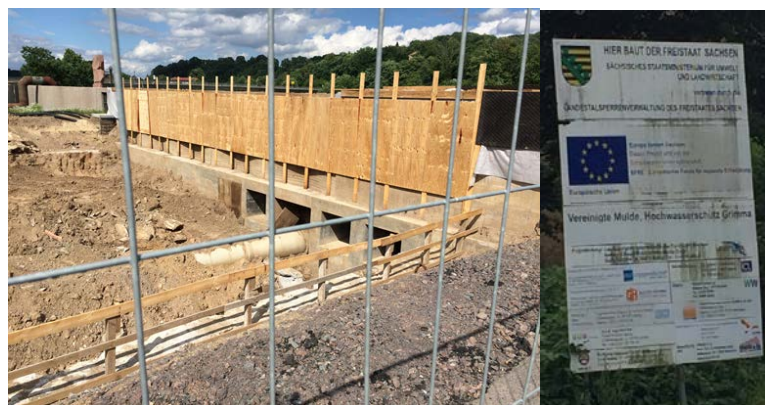
*Figure 31 Floodwall, project 4, under construction (June 2017)*

Project 4 begins at the Pöppelmann Bridge and leads to the end of the natural rock massif north of Grimma. A freestanding reinforced concrete wall is envisaged; on the north side of the Pöppelmannbrücke, the protection system runs inland to the foot of the bridge and then swings to the North to meet the new Mulde bridge in a line that is curved towards the river. The height of the flood protection system varies between 2,5 m and 3 m (hochwasserschutz-grimma.de, 2017). This project is still under construction (as to June 2017) and is expected to be finished by 2018 (LVZ, 2016) (Figure 31).

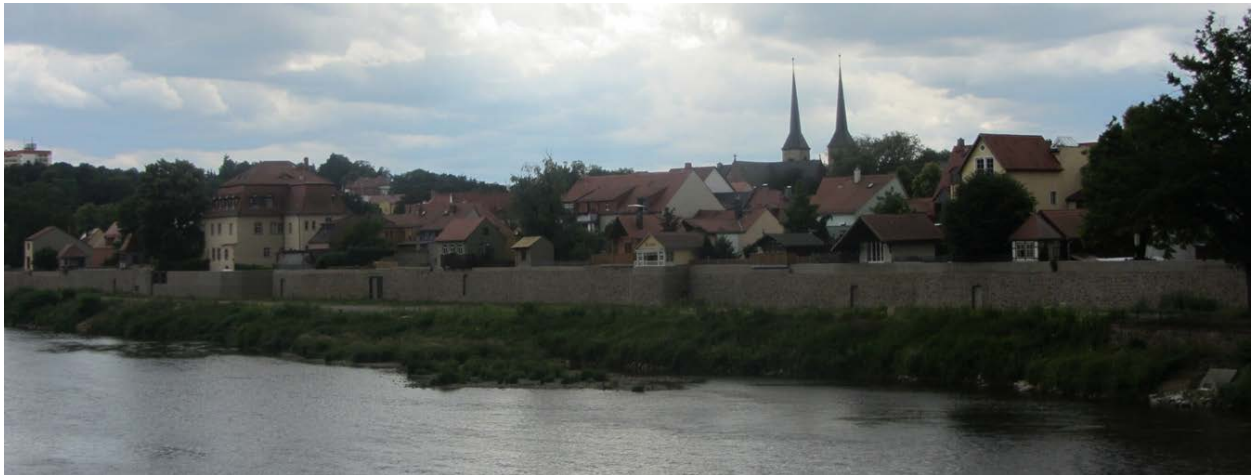
*Figure 33 New floodwall, photo taken across the Mulde River by the authors (June 2017)*

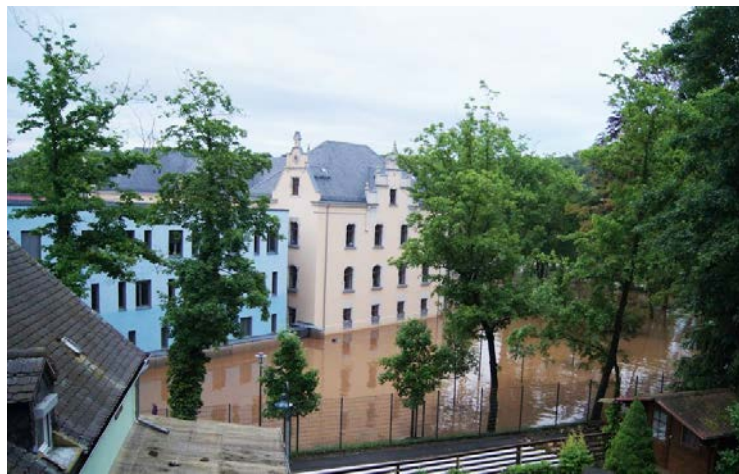
*Figure 34* New police station flooded during the 2013 flood  
(Colditzer-tageblatt online newspaper, 2013)

The 2013 flood caused damages of around 150 million euros in Grimma, with about 650 buildings damaged (Grimma Municipality, 2017). These included two schools, one music school, a kindergarten, the city hall, the district court and the new police station (Figure 34).

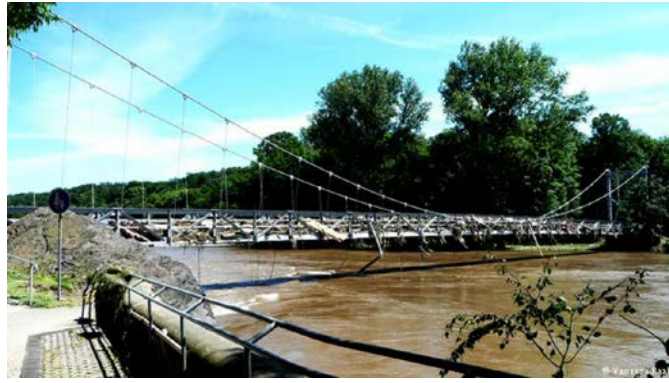
**Figure 35** *Suspension bridge covered in debris on June 6th 2013 (DW, 2013)*

The suspension bridge over the Mulde river was covered with flotsam and unpassable, though it was not damaged (Figure 35).

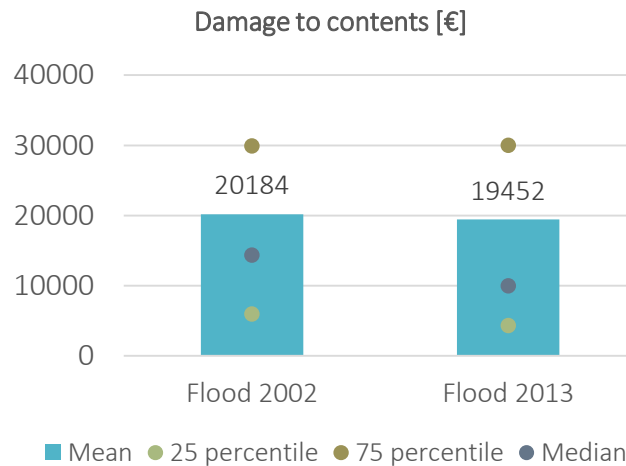
**Figure 5** Damage to household contents (corrected for inflation to 2013) within the samples in 2002 and 2013 floods.

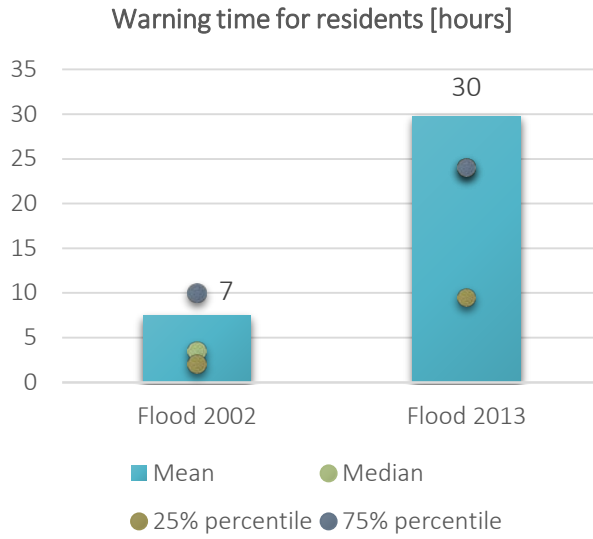
**Figure 40** Warning time for residents within the samples [hours]

In 2002, no timely flood warning was received in Grimma (Schanze et al., 2008). Data from the interviews at the household level (from University of Potsdam, German Research Centre for Geosciences and Deutsche Rückversicherung) show that the mean warning time that the residents had during the 2013 flood event was more than 4 times the one from the 2002 flood event (Figure 40). Other statistics such as the median and the mode also support this difference (Table 9).

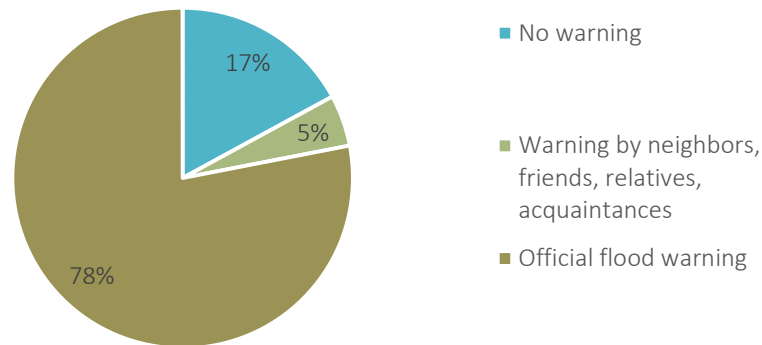
Figure 42 Flood warning distribution in households' data in the 2013 flood
